National Transportation Safety Board

Marine Accident Brief

Allision of the *Dale A. Heller* Tow with Marseilles Dam

Accident no.	DCA13NM017
Vessel name	<i>Dale A. Heller</i>
Accident type	Allision
Location	Illinois River, Mile Marker 247, Marseilles, Illinois 41°19.394' N, 088°42.507' W
Date	April 18, 2013
Time	1740 central daylight time (coordinated universal time – 5 hours)
Injuries	None
Damage	Barges: \$3,767,000; Dam: \$50 million
Environmental damage	Flooding damage to homes, businesses, and other property in the area
Weather	Heavy rainfall in the days preceding the accident led to high water and strong currents on the Illinois River
Waterway information	The Illinois River extends 333 miles from its confluence with the Mississippi River at Grafton, Illinois, to Lake Michigan at Chicago and Calumet Harbors, Illinois

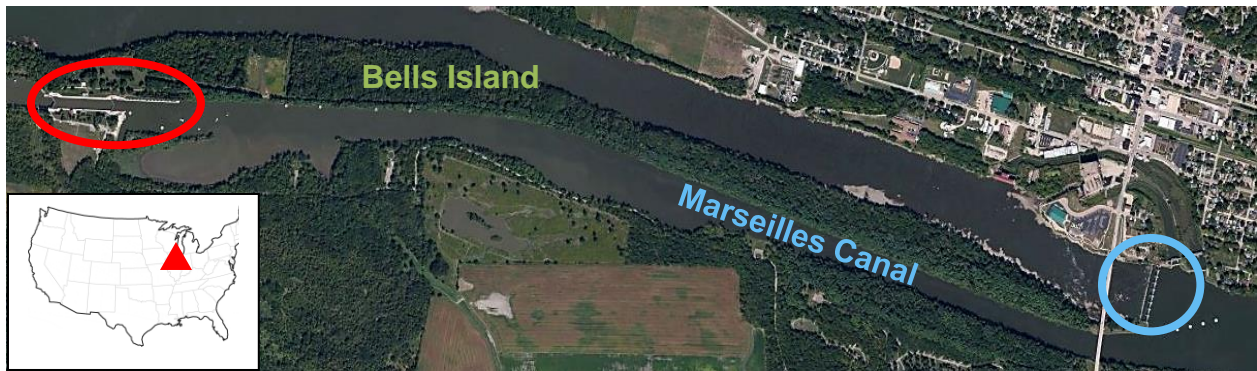
View of the Marseilles Lock (on the left, circled in red) and Dam (on the right, circled in blue). (Background by Google Earth) Inset in the image is the city of Marseilles's location on an outline of the United States; the city is located about 80 miles southwest of Chicago, Illinois.

The Marseilles Lock and Dam complex is located on the Illinois River between mile markers 245.5 and 247. The dam spans from the river's north bank to Bells Island. The lock is located about a mile and a half downstream (to the west) and is accessed via the Marseilles Canal, located between Bells Island and the river's south bank. The approach to the canal is separated from the dam by a line of five concrete pilings.

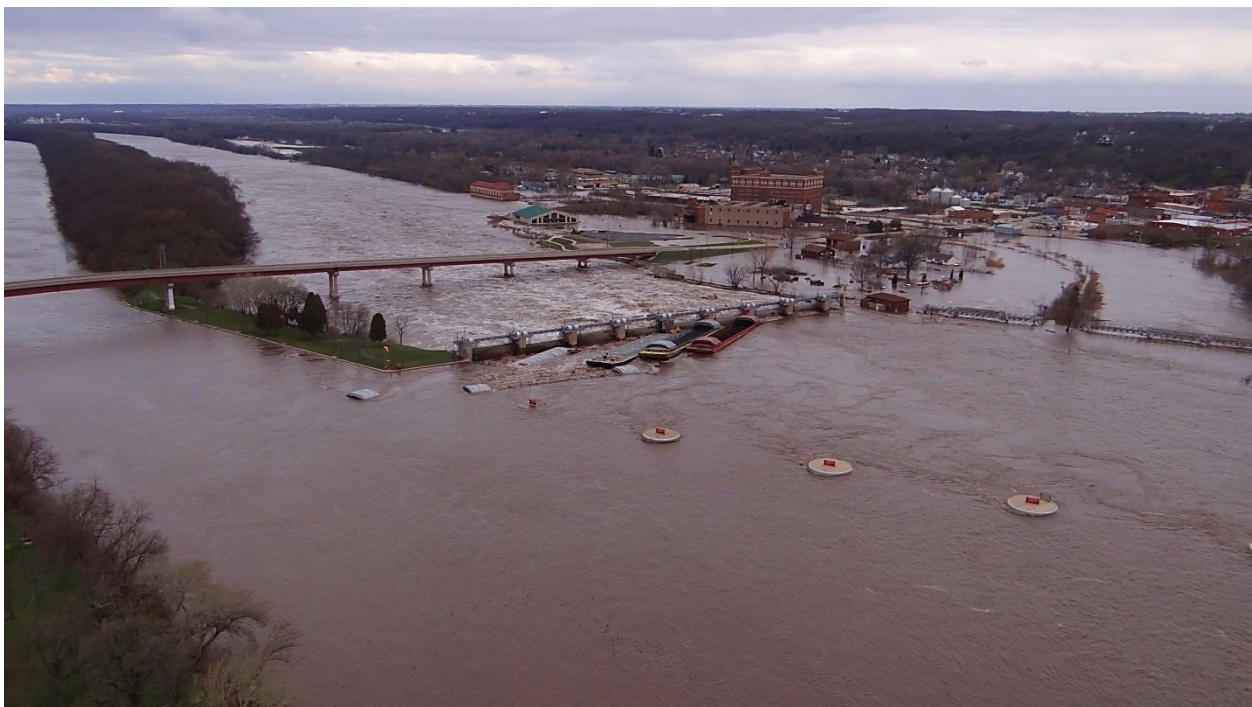
The Marseilles Dam after the barges broke away. Several barges can be seen pushing against the dam. The city of Marseilles, seen in the top right of the photo, flooded. (Photo by the Coast Guard)

Two of the barges were later determined to be a total loss. Five other barges were damaged but still operative. Damage related to the barges and the loss of their cargo totaled \$3,767,000. The Marseilles Dam sustained extensive damage in the allision. Gates 2 and 3 were rendered inoperative, while gates 4, 5, and 6 were less damaged and still operative. The total damage to the Marseilles Dam was estimated at between \$40 million and \$50 million. In addition, flooding in the city of Marseilles caused extensive damage to homes, businesses, and other property. Although the town may have flooded even if the allision had not occurred, the damage caused by the barge strikes likely exacerbated the flooding.

The National Transportation Safety Board determines that the probable cause of the allision of the *Dale A. Heller* tow with the Marseilles Dam was the decision by all involved parties to proceed with the passage of the tow during a period of record-high water and significant risk. Contributing to the accident was the failure of the Marseilles Dam lockmaster and the *Dale A. Heller* captain to communicate effectively about the actual positioning of the dam's gates before and during the transit.
